Project title	Increased reliability of heating systems on wind turbine blades
Project number	TG6-21
Organisation	Swerea SICOMP AB
Project leader	Lars Liljenfeldt
Other participants	Daniel Eklund, Runar Långström, Kurt Olofsson, Rolf Lundström
Report for	2016-01-01 – 2018-09-30
Participating companies	Skellefteå Kraft, Blade Solutions

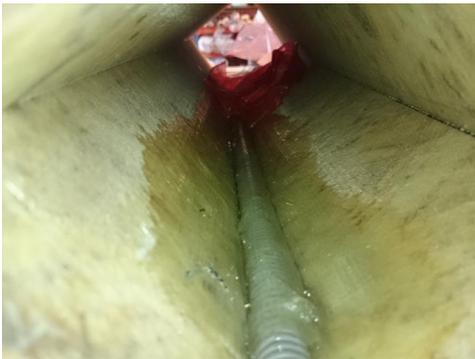
Figure 1: Wooden box with an imbedded tube where an electrical cable can be placed.

- Contacts with companies relining pipes. They are accustomed to working in narrow and long pipes.
- Experiments with different techniques to place a tube inside the prototype blade and evaluating adhesion for different material combinations.
- A box in wood was built to simulate the inside of a narrow and long blade, see Figure 1 below. A prototype equipment was designed and manufactured in order to conduct different experiments.

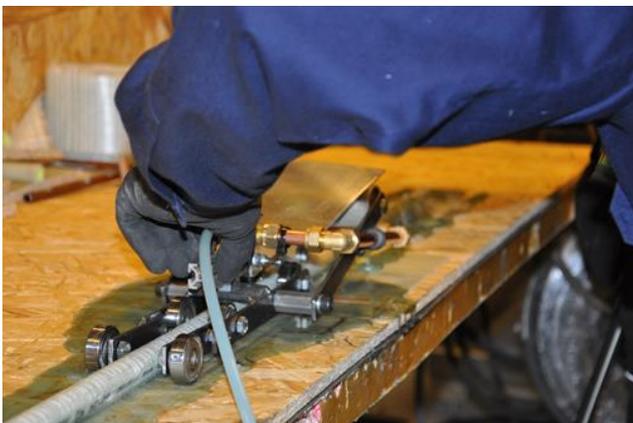
Figure 2: Development of equipment for attaching a tube in narrow spaces.

- Development of equipment, see Figure 2, to be able to place and attach a tube with glass fiber reinforcement and resin inside a blade.
- Verification test in laboratory where a tube was attached in a 12 m narrow box. The experiment was successful and documented with video camera.
- On-site verification test was conducted in December 2017 inside a wind turbine blade by Blade Solutions with support of personnel from Swerea SICOMP. The wind turbine is owned by Skellefteå Kraft and is located in the wind park Jokkmokksliden in the vicinity of Malå.
- In this particular case, a 3 m cable was attached directly on the inner surface of the blade. The same carriage as in the earlier verification test at Swerea SICOMP was employed.
- Two studies were conducted and completed:
 - A survey of temperature sensors in windmill blades.
 - Thermography for inspection of active blade de-icing systems.

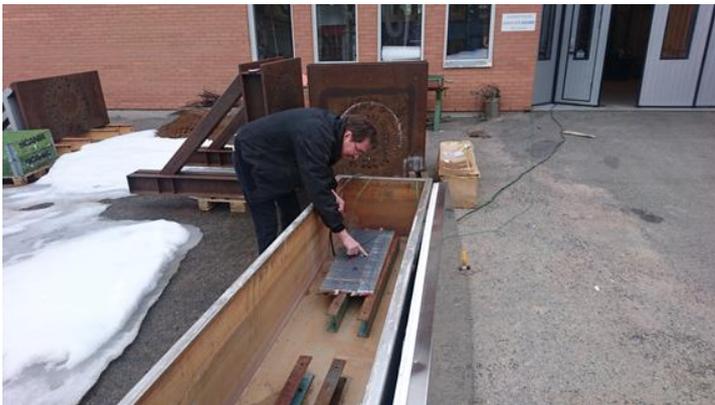
Figure 3: Outside long-term testing of test panels.

- Long-term testing to monitor the heating system, see Figure 3, and to find a method to detect cable breakage with RCD-equipment. The long-term testing caused no major damages as Skellefteå Kraft has experienced but indications exist for failure. The method for detecting cable breakage seems promising and should be developed further.
